# Improving

# Govan's

## shopfronts

This booklet is intended to offer guidance and advice on best practice for repairing, altering or restoring traditional retail frontages in Govan.

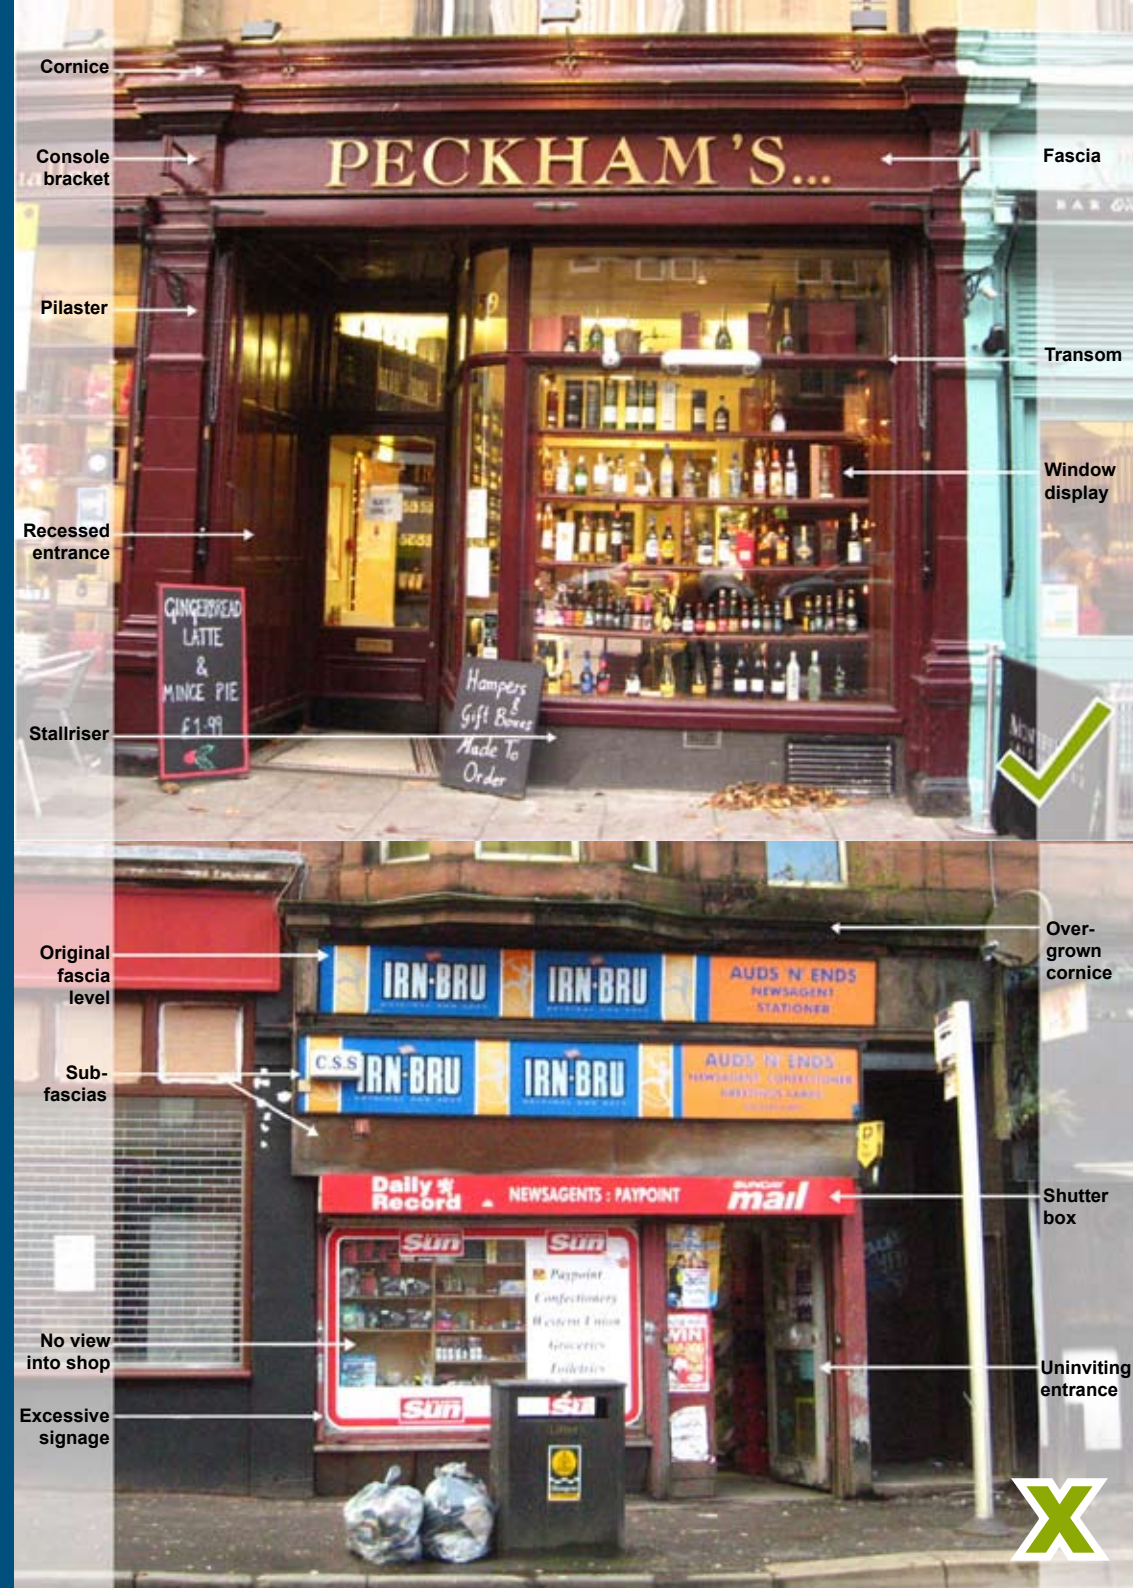
In order to carry out a successful shopfront improvement scheme it is first necessary to understand the principle of good design and what has gone wrong in recent years. The diagram opposite describes the various elements of a traditional shopfront and the image below shows a frontage that has suffered from inappropriate alterations and a loss of character.

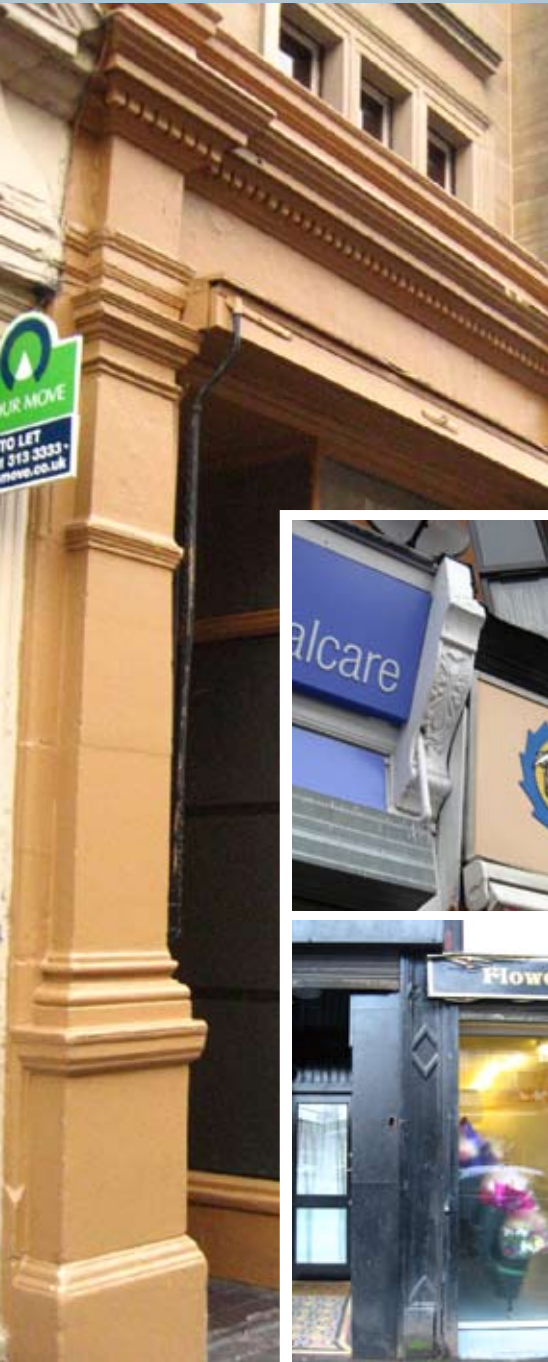
*Left: The two smaller images show traditional elements surviving in Govan. Above: Examples of inappropriate fascias, advertising & signage in Govan. Below: Good examples of traditional signage*

### Cornice

The cornice provides an attractive separation between the shop and the upper floors of a building. It also has a practical purpose – to throw water clear of the shop front to prevent decay. It is usually constructed of stone or timber with a lead flashing.

Console brackets provide a visual support for the cornice. They are often highly decorative and add to the character of a shopfront.

Pilasters are shallow columns that provide vertical separation between shops. Along with the cornice and console brackets they form a 'frame', which the rest of the shopfront should be contained within.

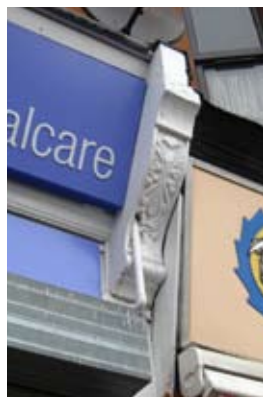
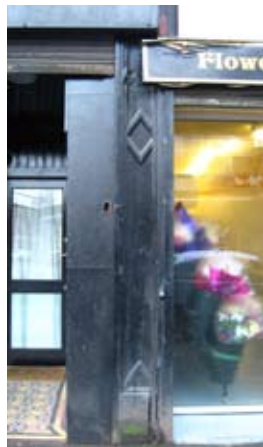
The fascia is a horizontal board situated beneath the cornice, usually constructed from painted timber. This is where shop signage should be situated. Many survive in Govan, often unused (see above).

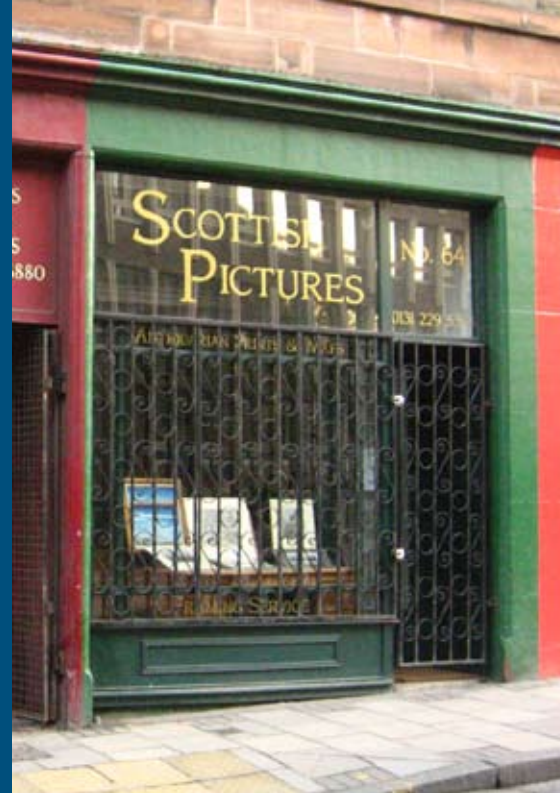
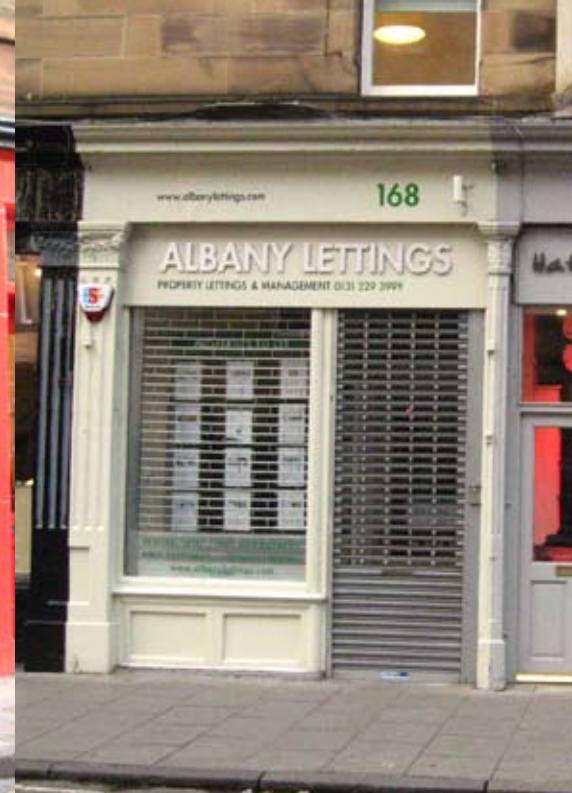
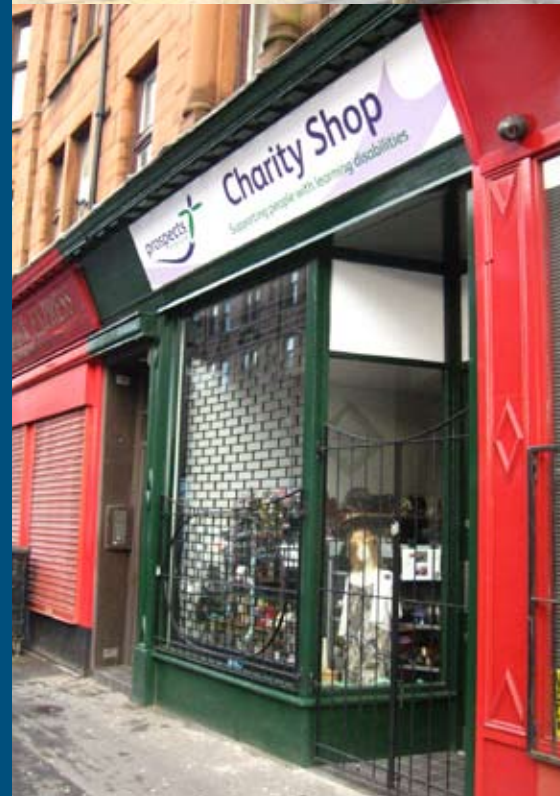
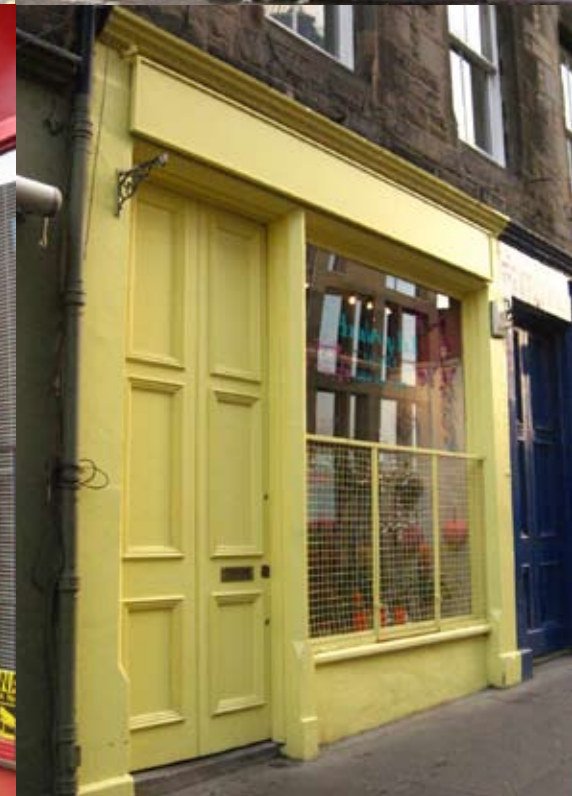
The images opposite show examples of where this has been achieved successfully elsewhere.

- Toughened, laminated safety glass;
- Removable external metal grilles, which can also be decorative;
- Internal shutter systems of the 'brick bond' open grille type;
- Improved CCTV & policing;
- A combination of all of the above.

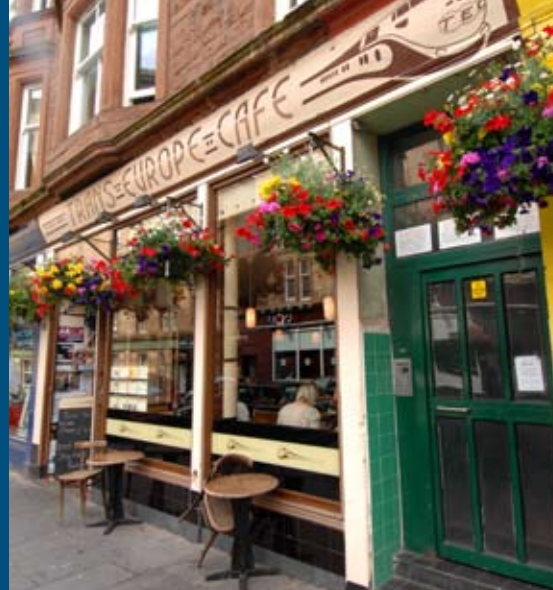
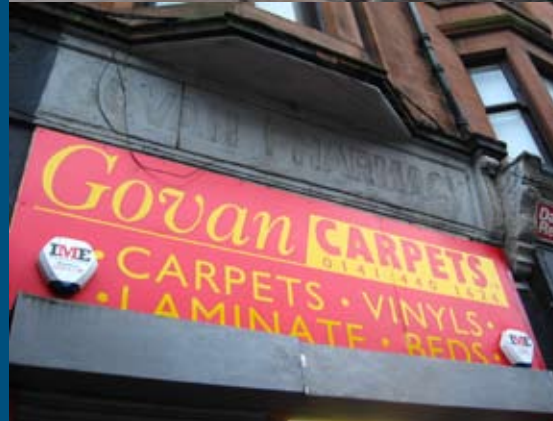
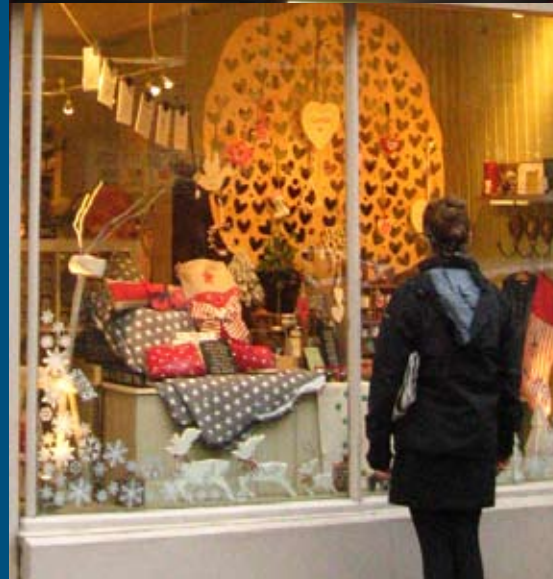
*Left, top to bottom: Hanging baskets add colour to a shopfront in the Merchant City (from Merchant City THI); The original fascia still exists above a sub-fascia on Govan Road; An Interesting window display in Brunsfield, Edinburgh, catches the eye of a passer-by.*
